# Corrosion and Mercury Release from Dental Amalgam

## Jaro Pleva, Ph.D.<sup>1</sup>

Corrosion attacks on twenty-two dental amalgam restorations after in vivo service have been studied by Scanning Electron Microscopy together with the Energy Dispersive X-Ray Technique, and by optical microscopy. From the measured depth and type of corrosion attack, estimates of released mercury amounts are made.

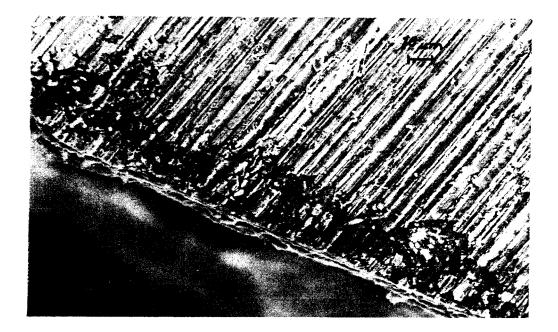
Figure 5. Cross section of amalgam crown with corrosion attack on buccal surface. Case C.

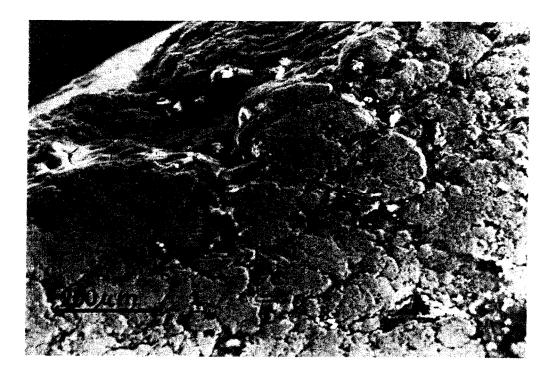
**Figure 6**. Selective attack of free amalgam surface at the margin. Five year old filling, intermittent contact to gold. Case A.

- selective corrosion, Fig. 6,

The selective corrosion of external surfaces, Fig. 6, reached depths up to 1.4 mm. The attack propagated into the filling, and was sometimes, but not always, filled with corrosion products, as shown in Fig. 7. The products contained only tin and chloride atoms. The subsurface selective attacks were connected to the bulk saliva electrolyte through the pores in the surface layer.

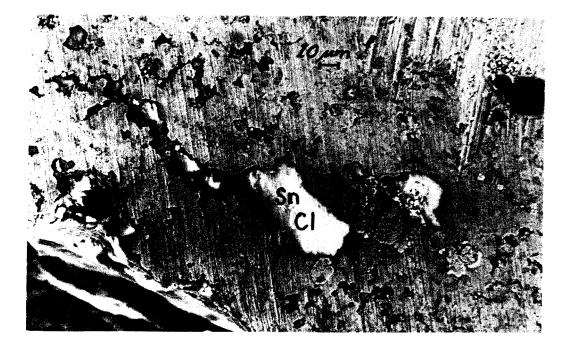
**Figure 7**. Cross section showing selective corrosion of gamma-2 phase. The cavities are filled with corrosion products containing tin and chlorine atoms. Case B.

The content of  $Sn_7Hg$  may vary within large limits. Brecht-Bergen<sup>26</sup> found contents between 0.06 an 59 weight %, but in most cases 11 -36 will be more realistic.<sup>22</sup> In Fig. 7, the content of gamma-2 has been roughly estimated to 20 volume %. Using specific densities for gamma-, gamma-1 and gamma-2 phases given by Marxkors,<sup>22</sup> the content of gamma-2 can be calculated to 15 weight % Sn<sub>7</sub>Hg. The mercury content of Sn<sub>7</sub>Hg is about 20 weight %.

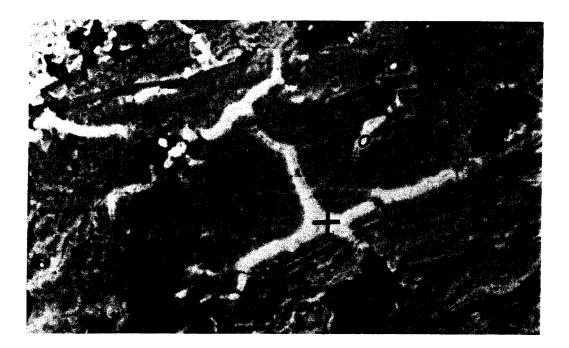
**Figure 8.** Segregation of mercury to certain areas of the occlusal surface. Point of EDX-analysis is indicated. Note also corrosion attacks of the surface. Case C.

On the occlusal surface of the amalgam crown from patient C segregation of mercury to certain areas has been observed. The secondary electrons image in SEM is shown in Fig. 8 as bright lines reminding of grain boundaries.

been observed on the occlusal surface, Fig. 8. The segregation seems to be irreversible. Increased mercury content in the grain boundaries of conventional amalgam, caused by biting pressure, has been previously noticed by Walter.<sup>17</sup>

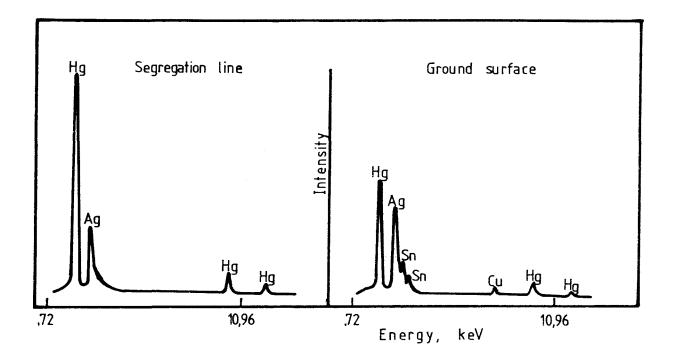
**Figure 9.** Comparison of EDX-spectra of the bright lines in Figure 8 (left spectra, point analysis) with average spectra of a ground surface (analyzed surface  $300x200 \text{ } pm^2$ ).

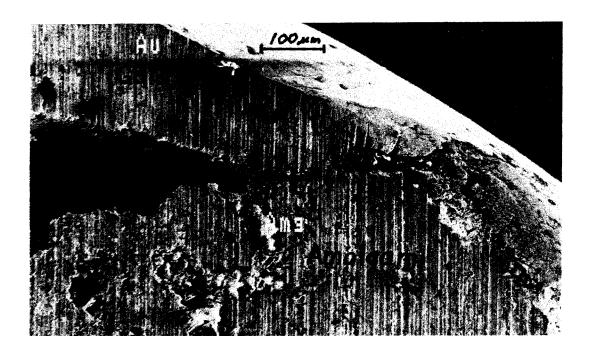
Figure 10. Galvanic corrosion of silveramalgam (Amg) under a gold crown (Au). Case B.

As expected, amalgam under gold crown in Fig. 10 suffered strongest attack near the contact to gold. Depth of corrosion is around 100 *u*m.

The visible cavity under the crown may be an imperfection from tooth reconstruction, but there are signs that corrosion has also been involved. The cavity is connected to the bulk environment through channels in the amalgam. The channels are partly filled with corrosion products of low electrical conductivity, giving high brightness due to charging in SEM. Fig. 11 shows four quadrants of a stainless steel screw-post, emerging in the occlusal surface due to abrasion of amalgam. The vicinity of the stainless area suffered increased corrosion, compared to the rest of the occlusal surface.

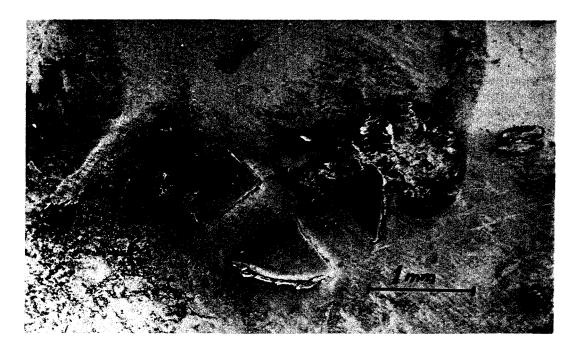
Figure 11. Occlusal surface of an amalgam crown with emerging stainless steel screwpost. Galvanic corrosion occurred in vicinity of the stainless area. Case C.

No sign of corrosion has been observed on the screwpost itself. The EDX-analysis indicated a chromium-nickel-manganese alloyed stainless steel with molybdenum addition.

Though the combination of gold and amalgam is the most frequent case of oral galvanic cell, galvanic corrosion can occur between many other metals used for dental restorations. An example is shown in Fig. 11. Due to wear of the occlusal surface, the stainless steel screwpost emerged in the surface. Increased corrosion of amalgam is observed in close vicinity of the stainless surface. Crevice corrosion may also have been involved.

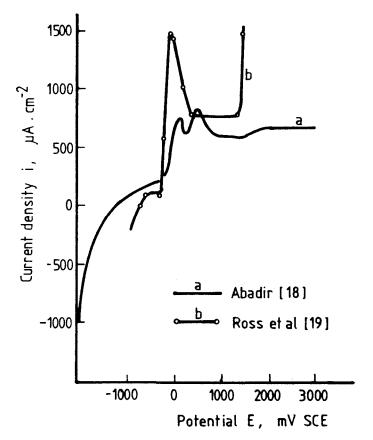
**Figure 12.** Potentiokinetic polarization curve of silver-tin-mercury dental amalgam alloy at 25° C - a) in 0.2% NaCl (after Abadir, 8), b) in synthetic saliva (after Ross et al, 19).

Calomel Electrode) Amalgam: -310 mV SCE These values have been compared to polarization curves measured by Abadir<sup>18</sup> and Ross<sup>19</sup> on the same type of amalgam, Fig. 12. The impact of an anodic polarization of amalgam in the galvanic couple on increase of the corrosion current and amounts of released mercury will be discussed in one of the sections below.

The values of measured corrosion potentials have been compared with the polarization curves measured by Abadir<sup>18</sup> and by Ross,<sup>19</sup> Fig. 12. Anodic polarization to over -200 mV caused primarily release of tin, at slightly nobler potentials also silver.<sup>18</sup> The polarization curves indicate, that anodic polarization of amalgam may increase the corrosion rate to over 1000 *IxA/cmr<sup>2</sup>*.
